Technical Report GL-94-13
April 1994

Archaeological Geophysics Investigation of the Wright Brothers 1910 Hangar Site: Wright-Patterson Air Force Base, Ohio

Prepared for U.S. Army Construction Engineering
Research Laboratory

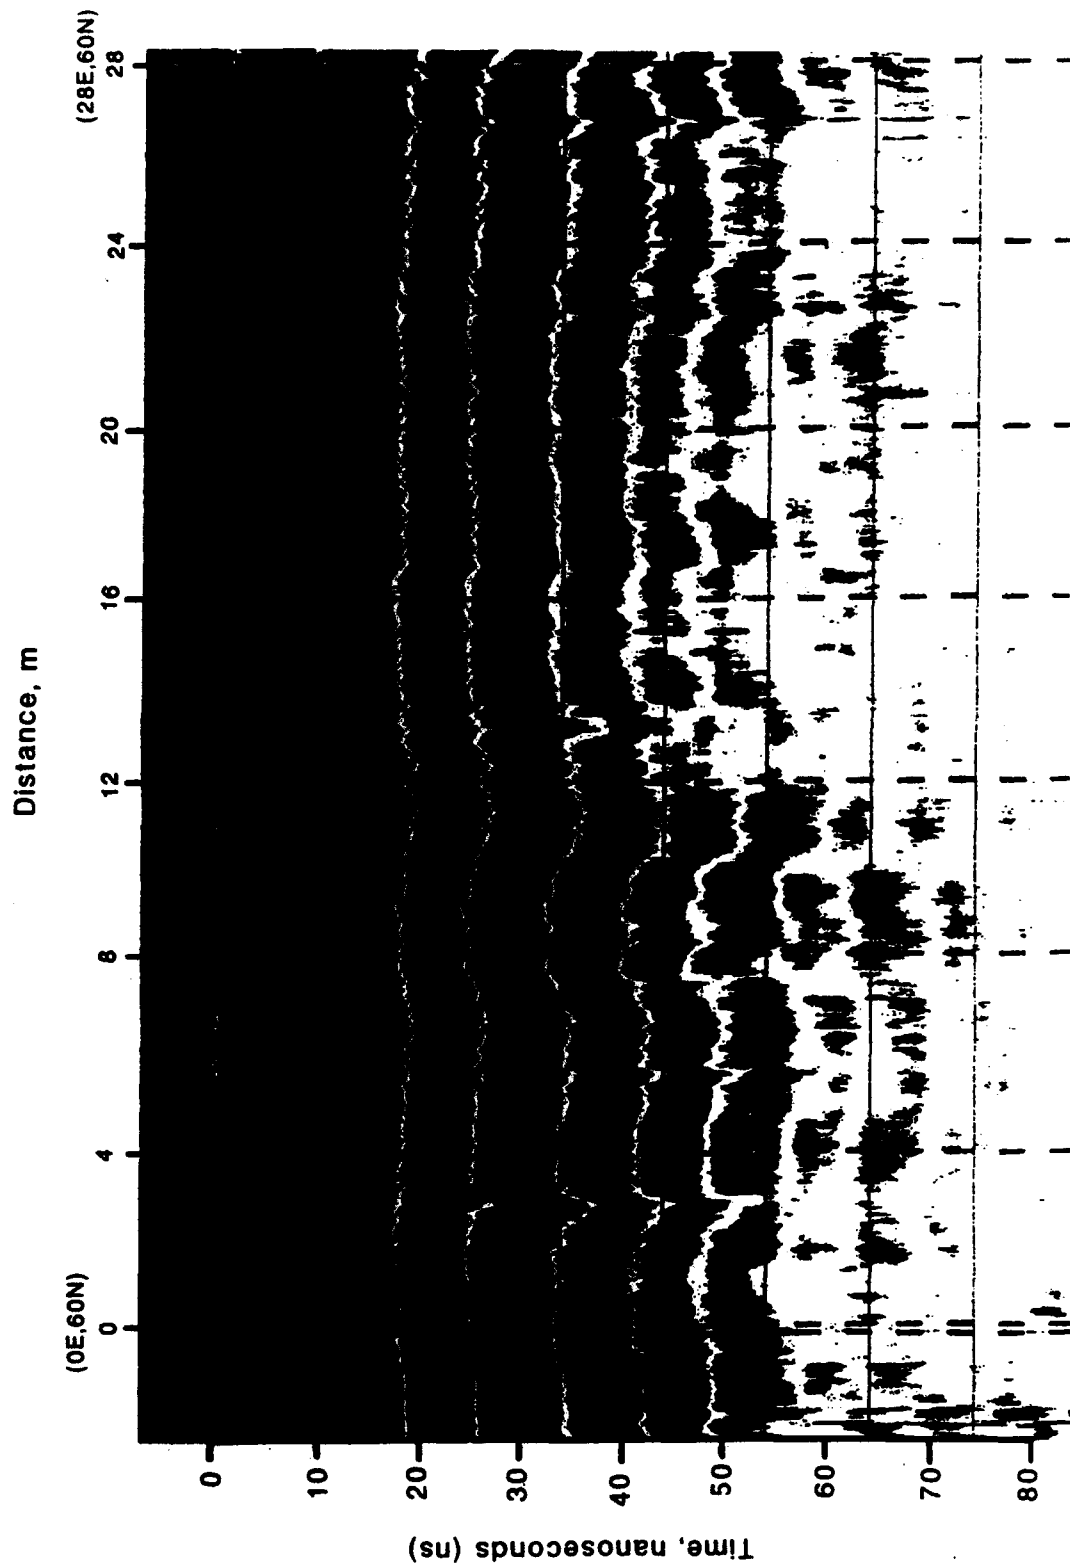
Figure 16. GPR survey line 60N, from 0E to 28E, illustrating appearance of record for relatively uniform or undisturbed conditions (300 MHz antenna)

GPR survey records from this site are typically 0.28 by 1.35 m in size; and, since 34 different lines were surveyed, reproducing all the GPR records in a convenient size is impractical. Only selected portions of the GPR records that illustrate typical features are included here. The GPR records were examined and classified by the following criteria: (1) undisturbed areas; (2) 'shallow', extensively disturbed areas (< 1 m); (3) 'deep', extensively disturbed areas (> 1 m); (4) anomalous area or feature; (5) localized anomaly. Undisturbed areas have no significant, identifiable anomalous subsurface conditions, i.e., uniform conditions laterally and also vertically, except for near-horizontal strata (Figure 16-18). Localized anomalies appear as hyperbolic signatures opening downward (Figure 17); the size of the hyperbola depends the size and depth of the subsurface feature relative to the wavelengths of the GPR. The 1 m depth selected to classify 'shallow' versus 'deep' disturbed areas is arbitrary. An example of a shallow, extensively disturbed area is shown in Figure 17; individual, localized anomalies can sometimes be identified in disturbed areas, but in general they are too small and closely spaced for individual identification. An anomalous area and a deep, extensively disturbed area are shown in Figure 18. The anomalous area in Figure 18 has a definite signature that extends over approximately 10 m laterally and is also identifiable on other survey lines (0N, 8N, 12N, 16N); anomalous areas like this one may be geologic in origin.

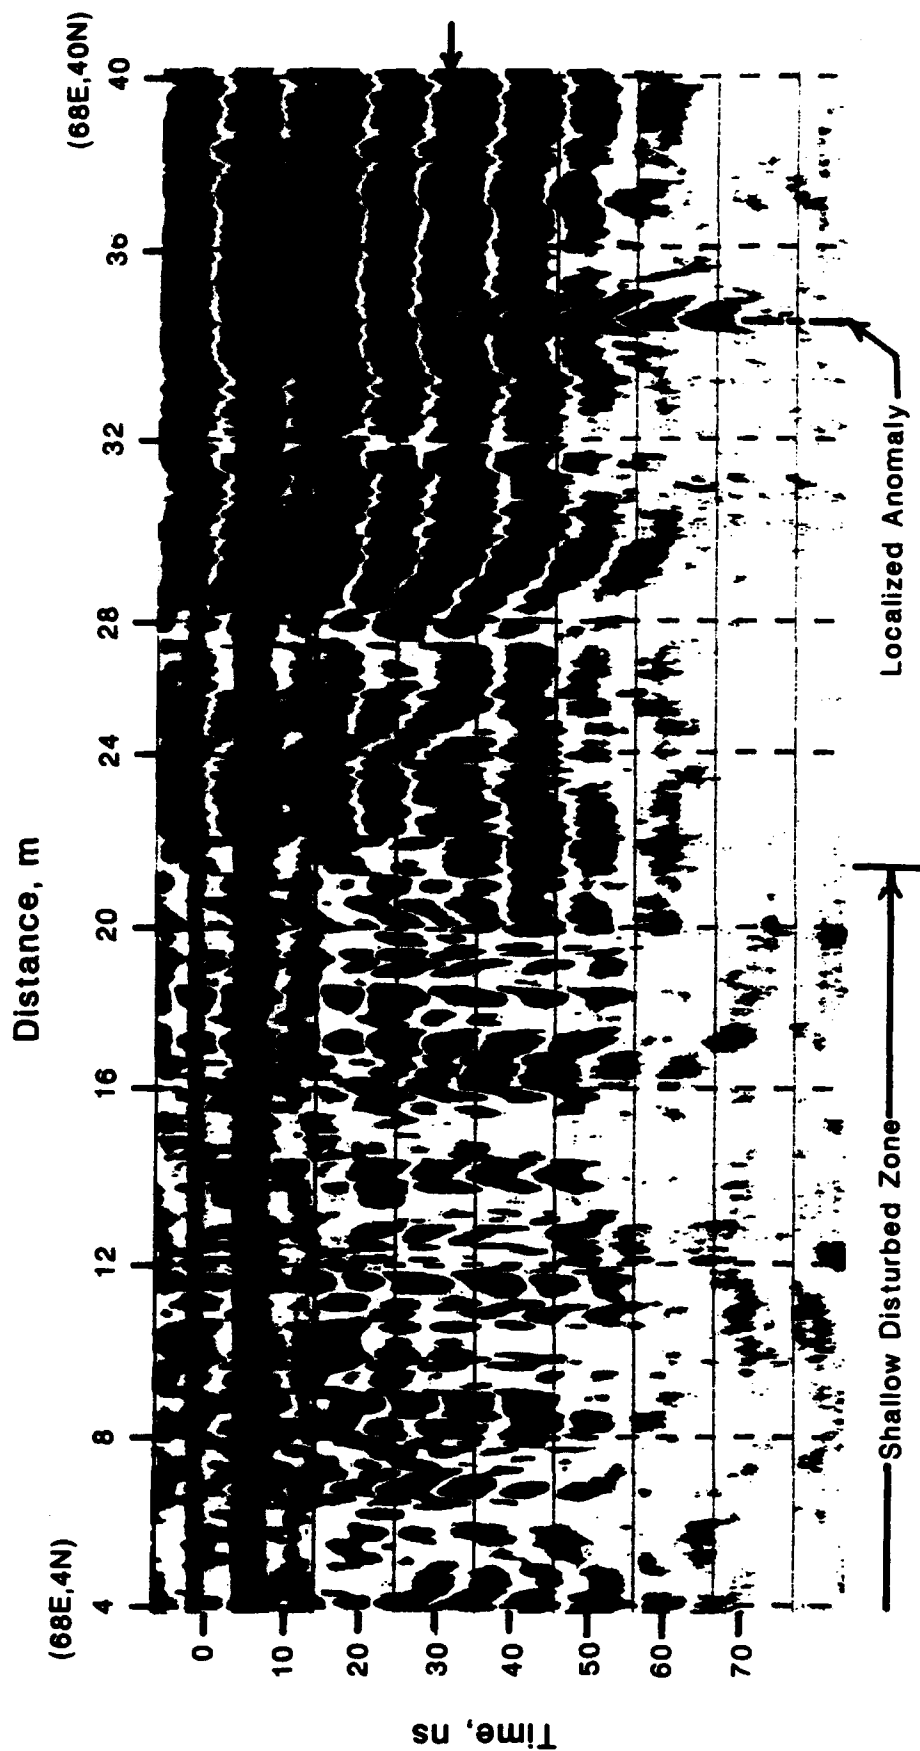
Figure 17. GPR survey line 68E, from 4N to 40N, illustrating appearance of record for a shallow extensively disturbed zone and a localized anomaly (18 in. storm drain)

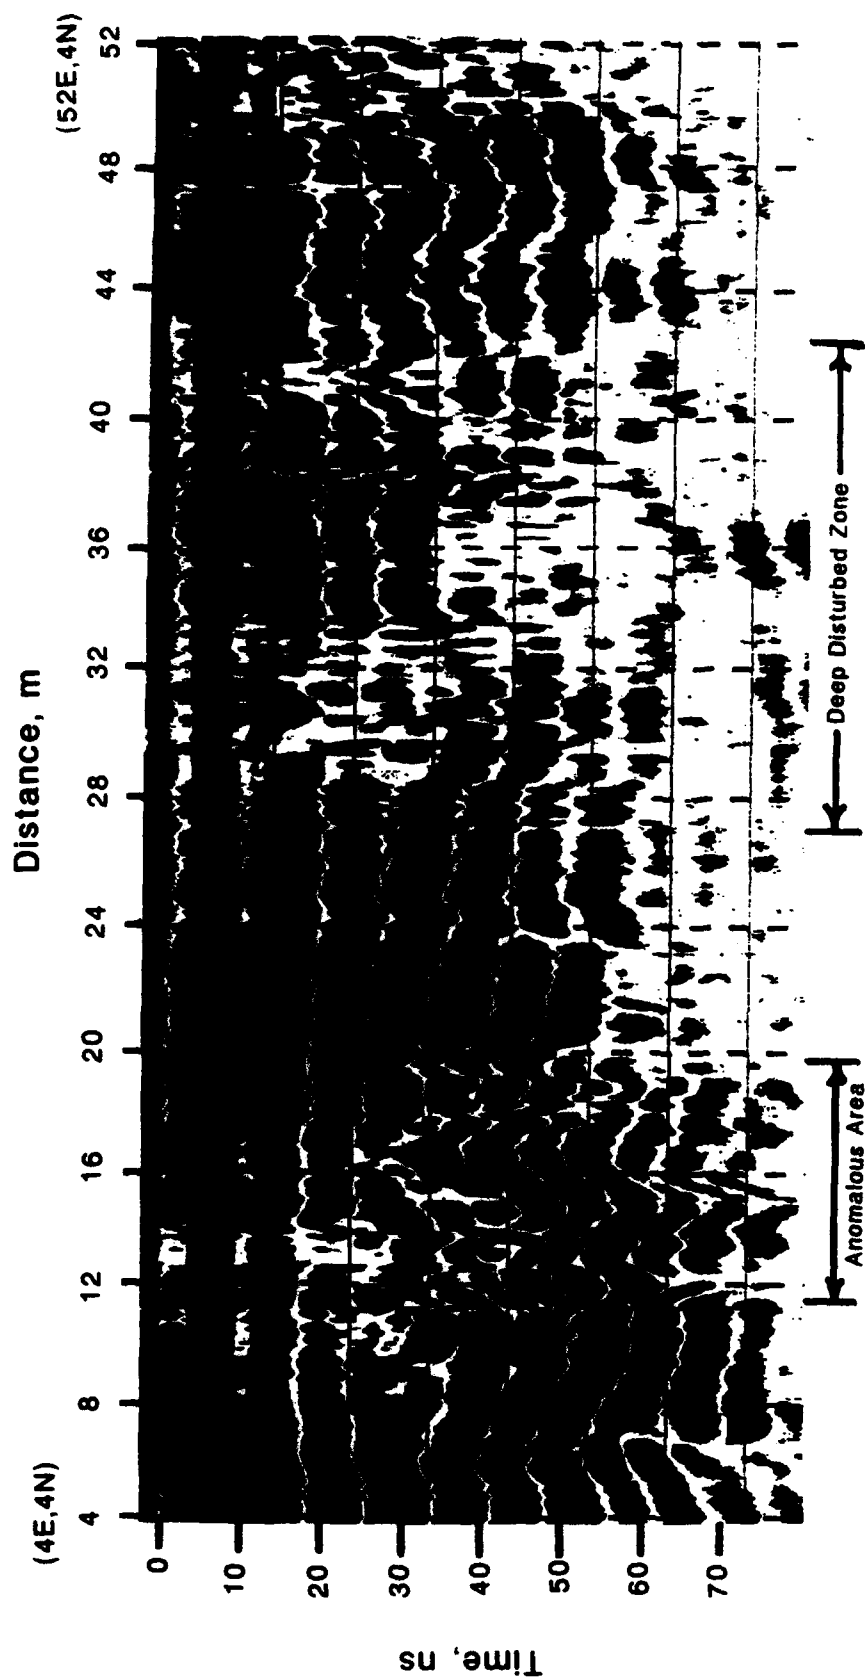
Figure 18. GPR survey line, from 4N to 52N, illustrating appearance of record for an anomalous area and a deep extensively disturbed zone

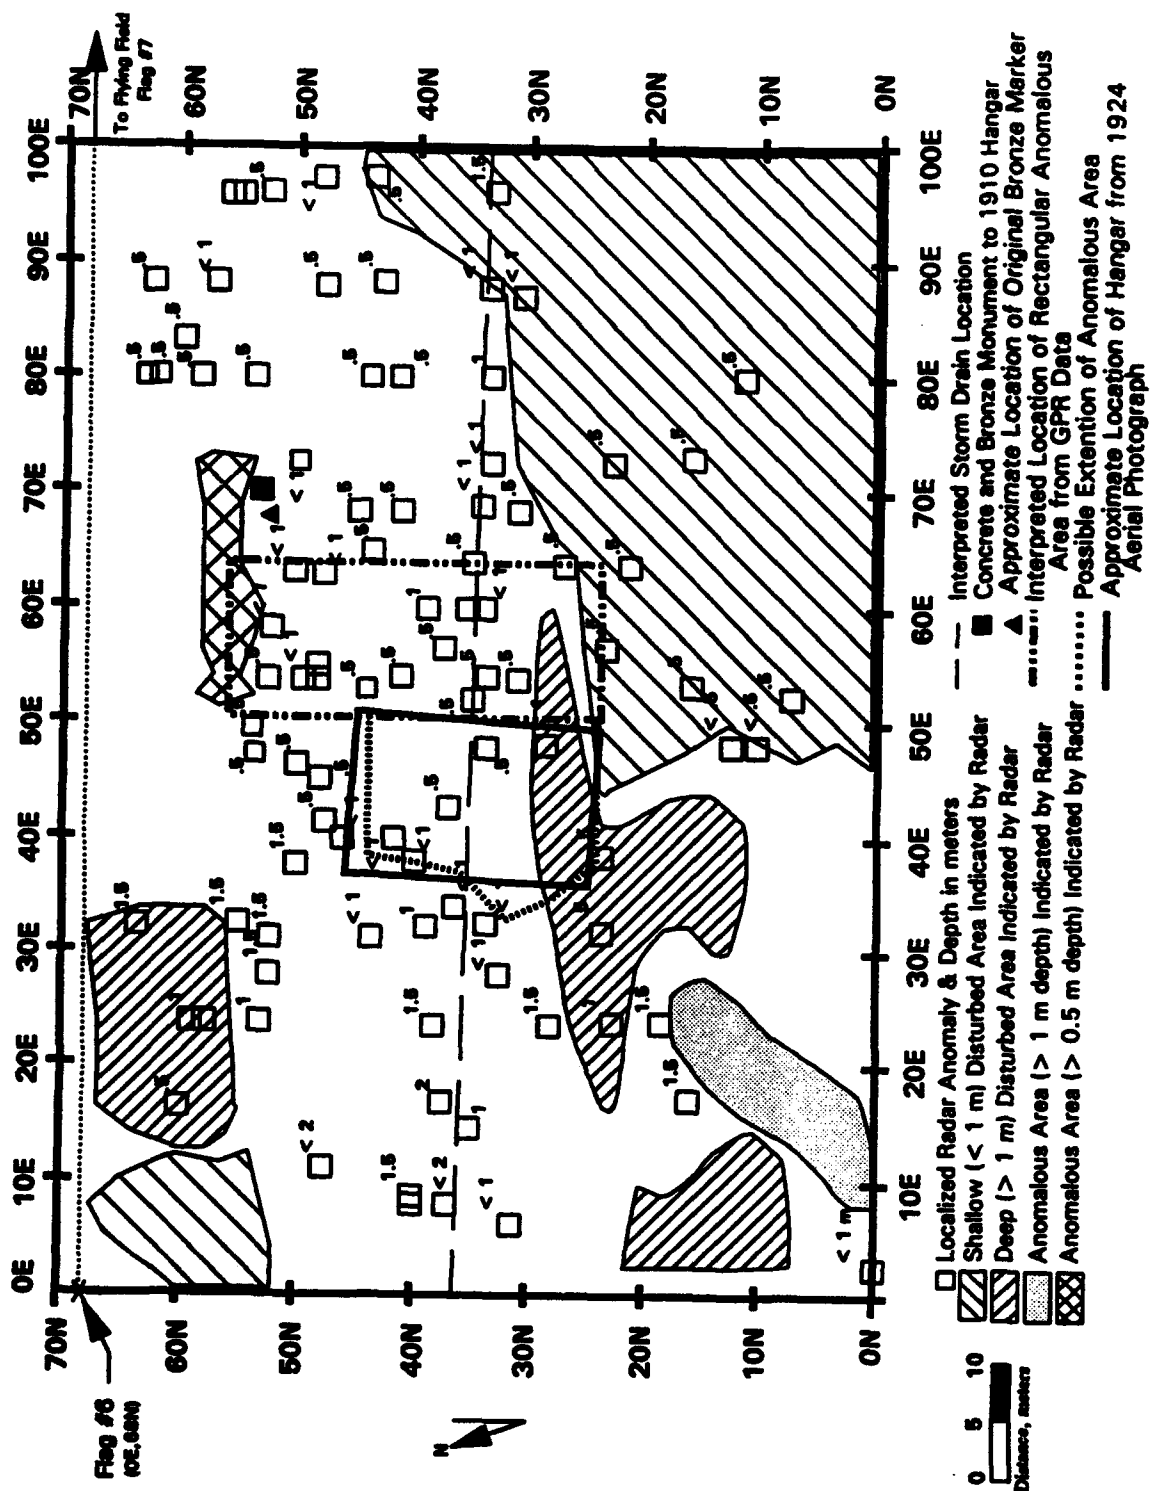
Figure 19. Summary location map of GPR anomalies

Localized anomalies are potential cultural artifacts; buried tools and aircraft parts could produce localized GPR anomalies. The most obvious and significant localized anomalies are indicated in Figure 19; the figure also shows two anomalous areas (see Figure 18) and shallow and deep disturbed areas. The number associated with each localized anomaly marker is the approximate depth in meters. During the conduct of the GPR surveys, a "significant anomalous area" was detected; the GPR signature of this anomalous area is shown in Figure 20 for east-west survey along line 52N. This anomalous area was detected on east-west lines as well as north-south survey lines and defines an *approximately* rectangular area (see Figure 19). Even during the conduct of the surveys, the possibility that the anomalous area could be the location of the hangar was suggested. The GPR signature is complex, as indicated in Figure 20. A large number of localized anomalies are within the rectangular area. The localized anomaly on north-south survey line 68E (Figure 17) is interpreted to be caused by the concrete storm drain (18 in dia.) which crosses the site. The storm drain is detected on at least 10 of the north-south survey lines, and its interpreted location is shown as the dashed line (approximately east-west across the survey area) in Figure 19 and other figures which follow.

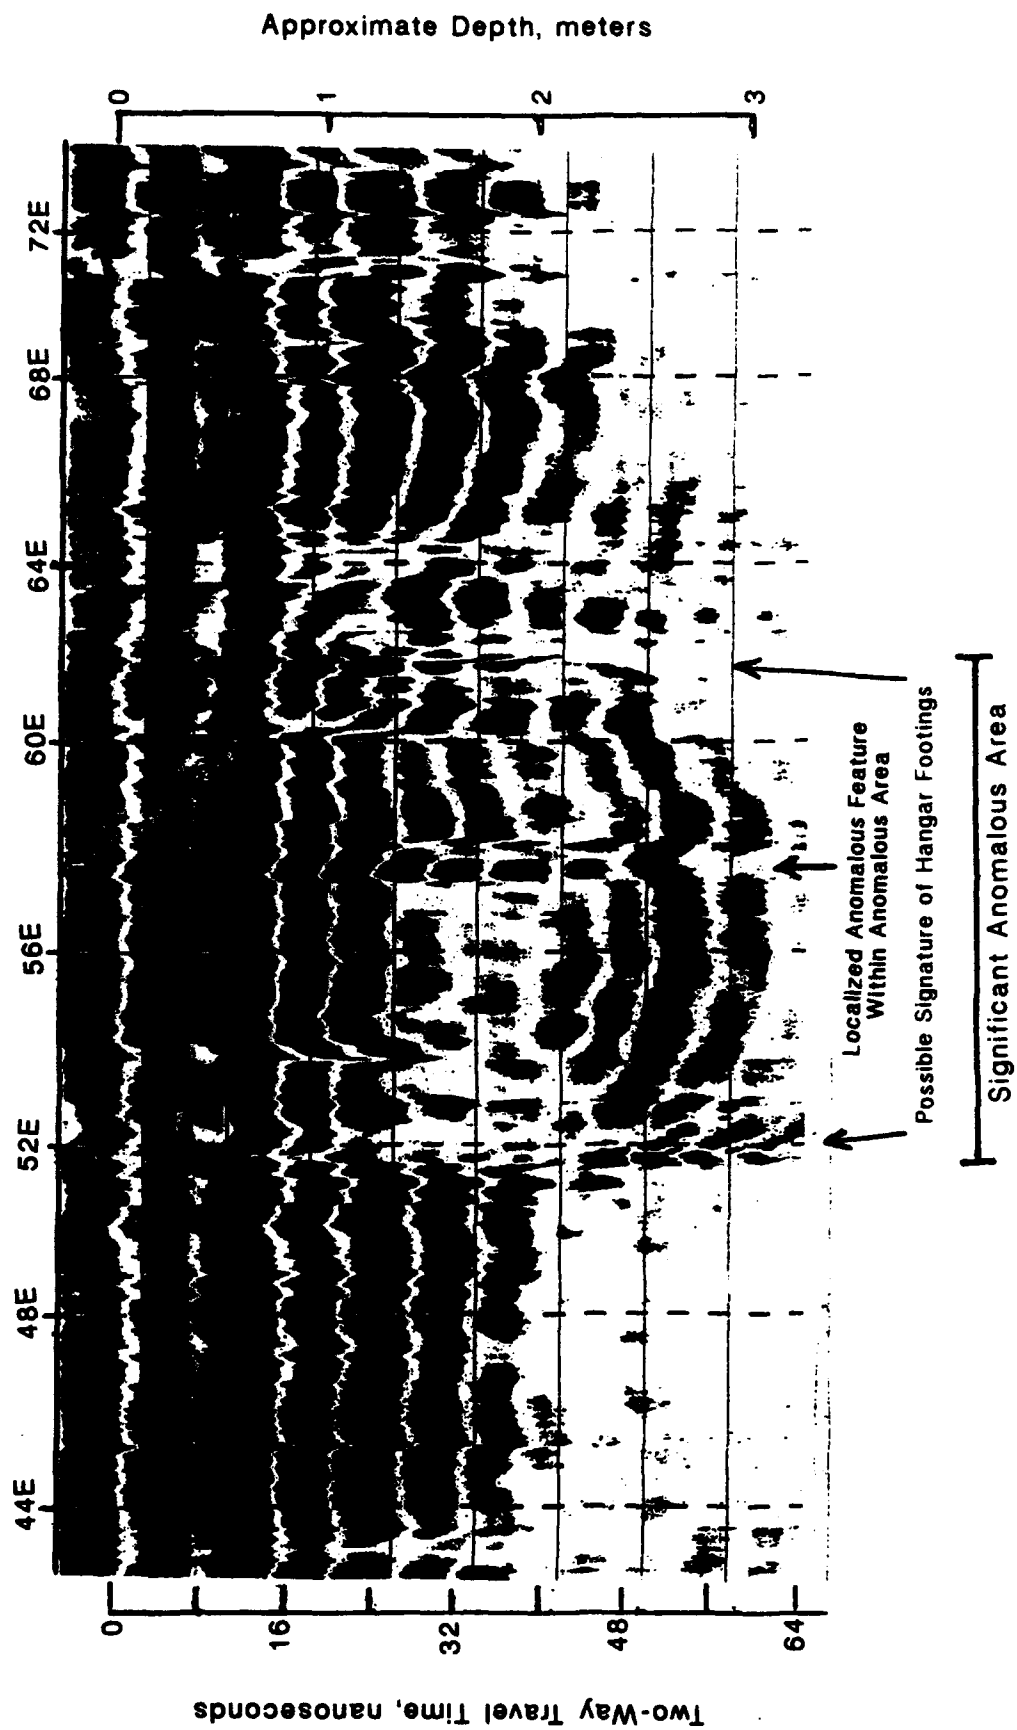
Figure 20. GPR survey line 52N, showing the "significant anomalous area", initially interpreted as the hangar foundation

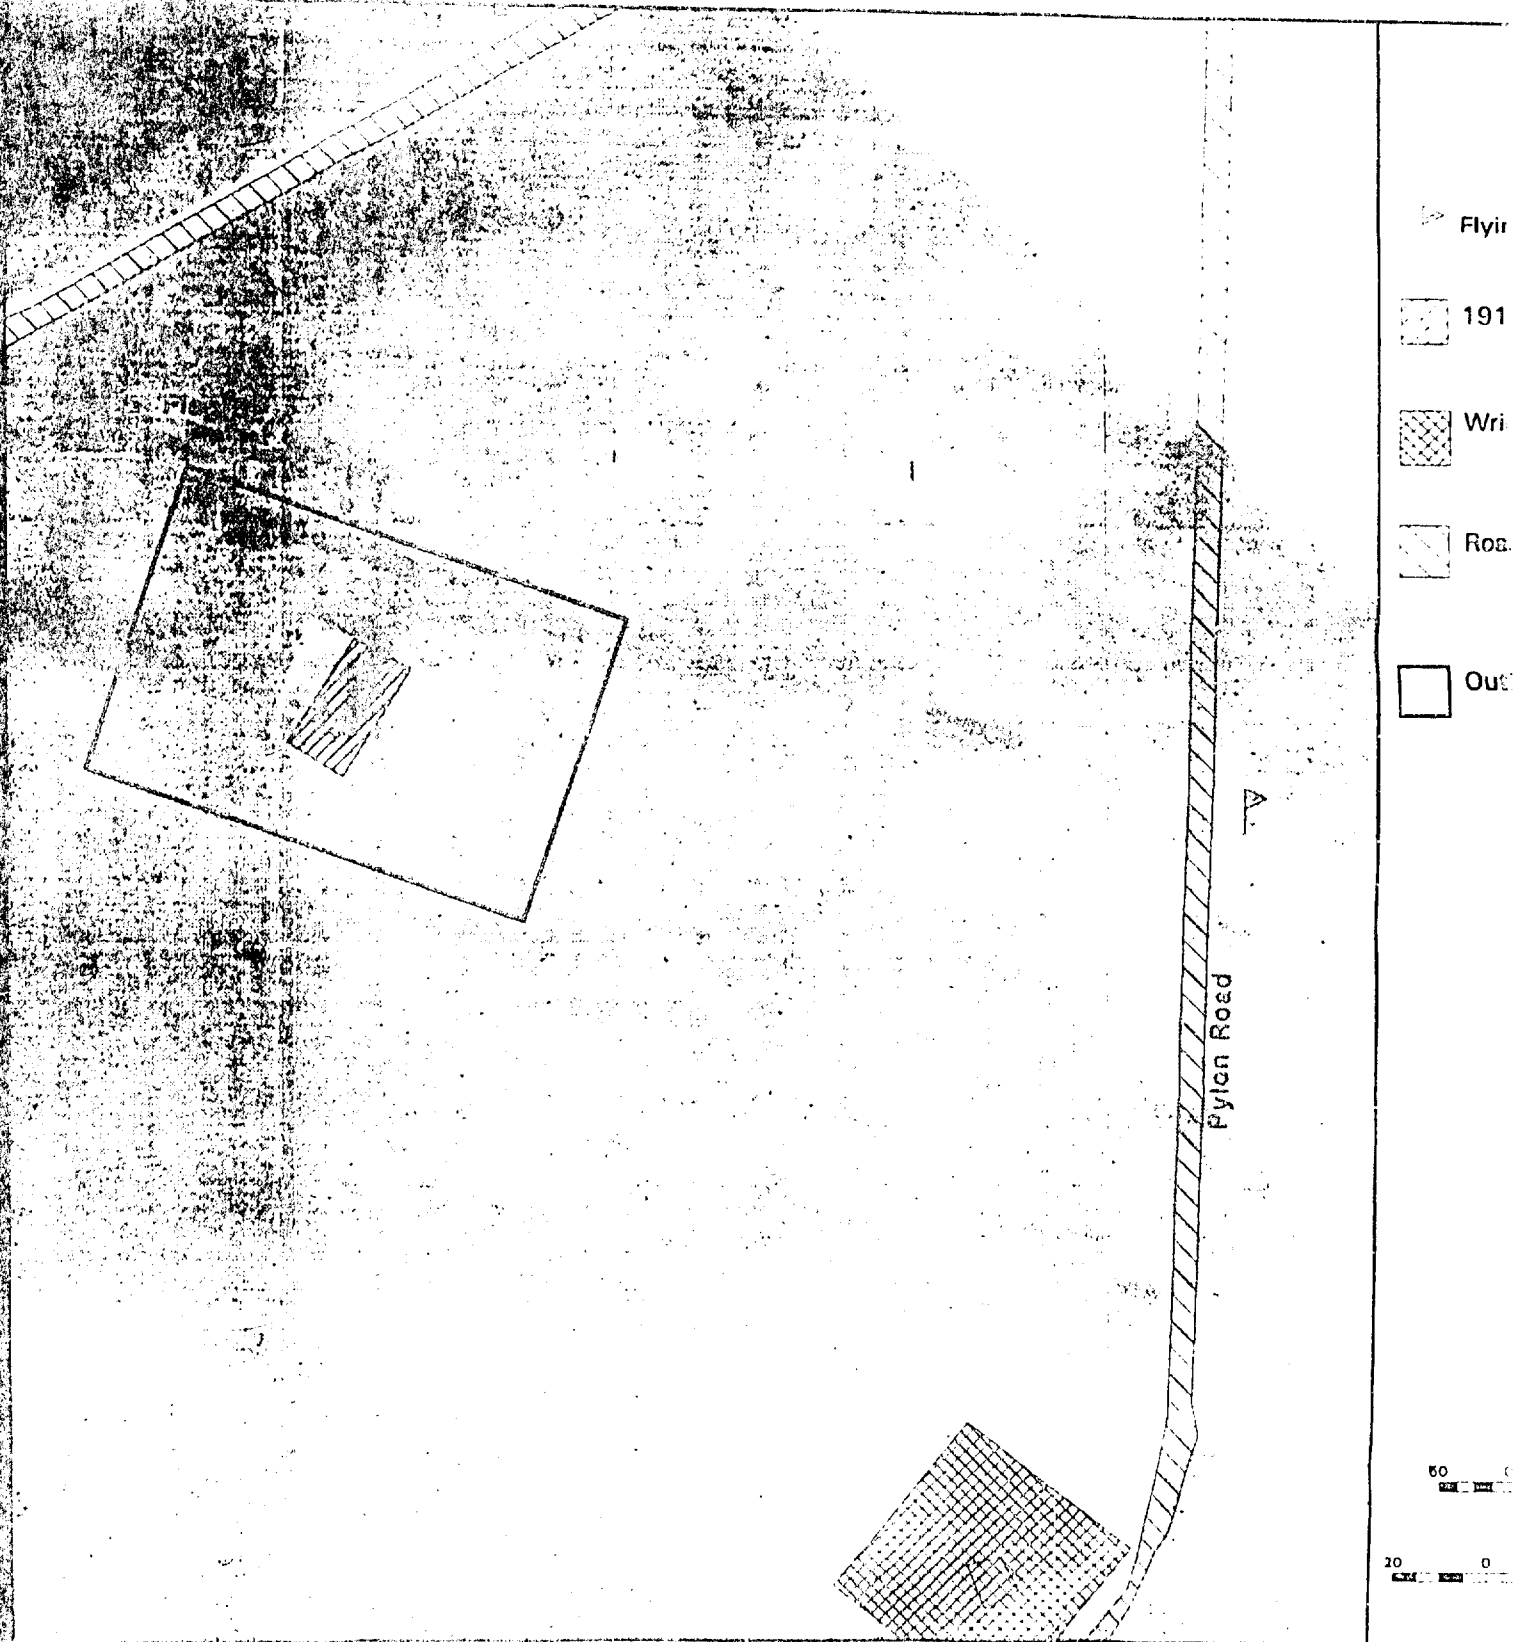
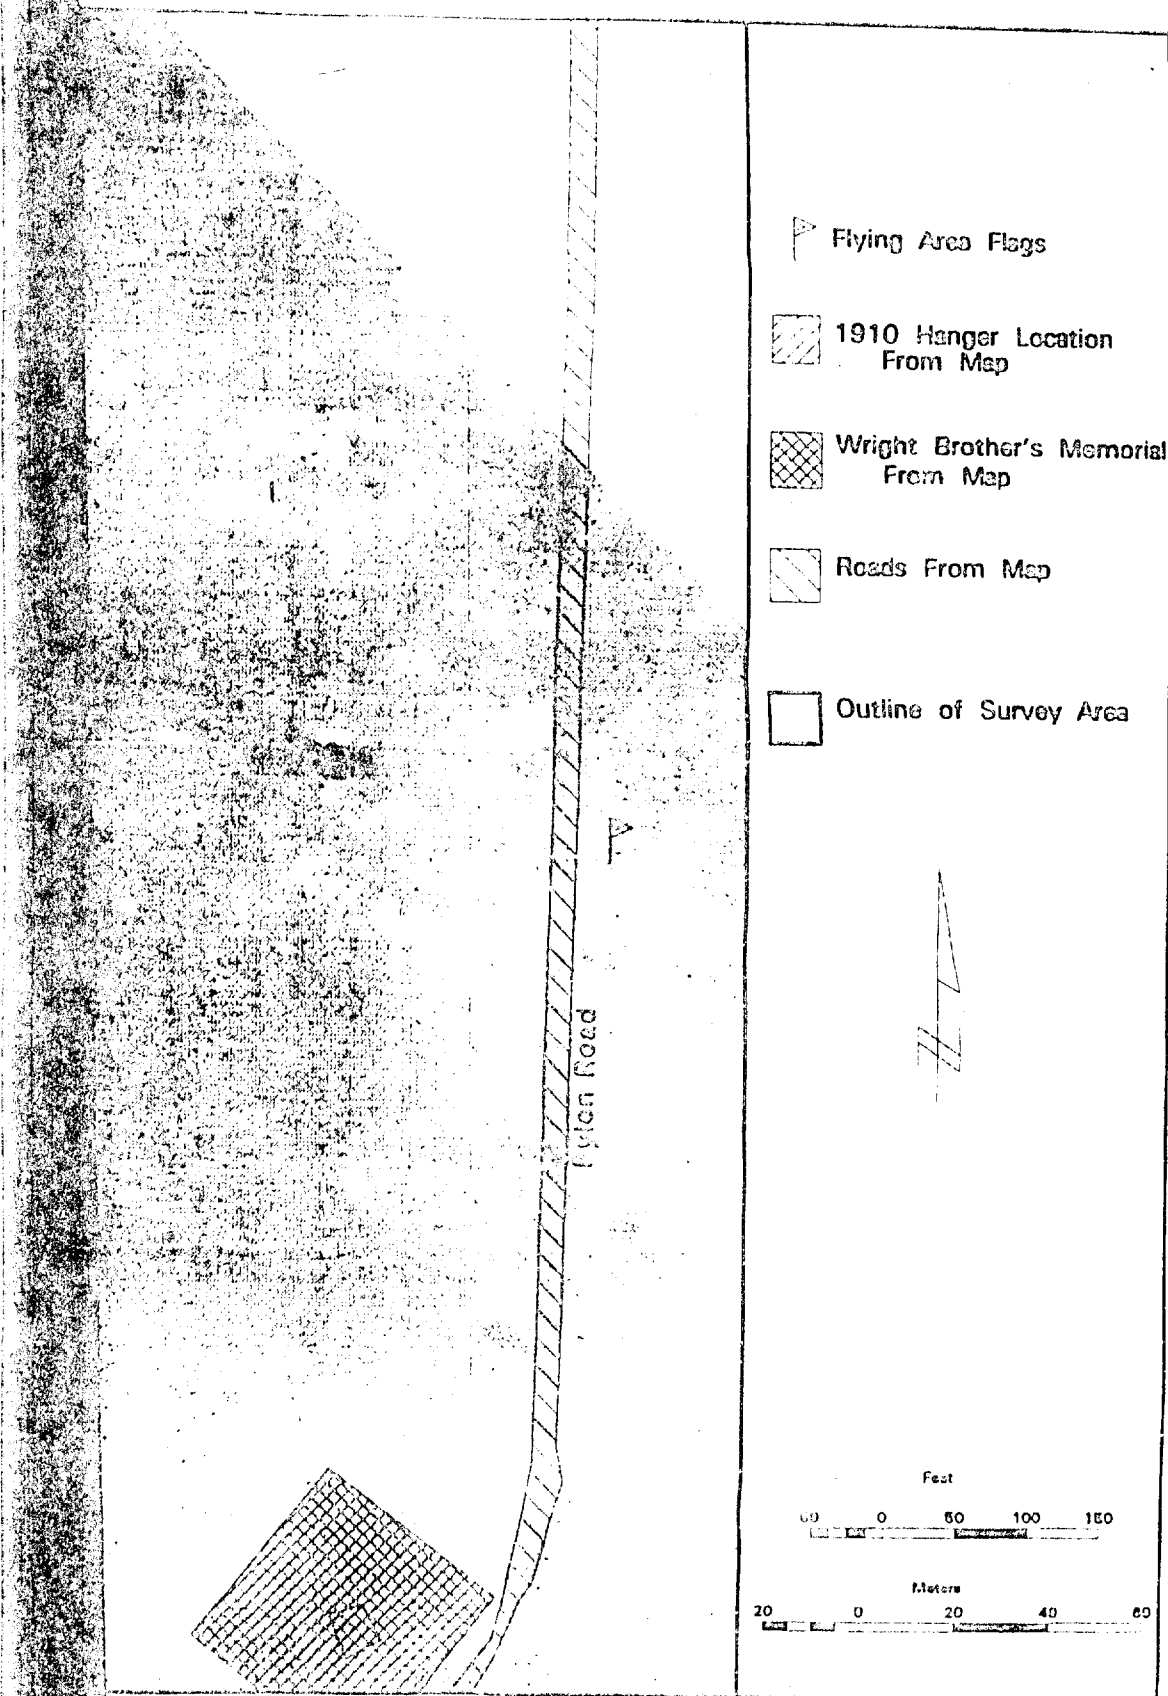
Figure 21. Scanned version of 1924 aerial photograph of

24 aerial photograph of flying field area showing the 1910 hangar

Results of scanning the 1924 aerial photograph (Figure 2) and georeferencing to digitized current WPAFB facilities map information (e.g., Figure 3) is shown in Figure 21. The hangar location shown on a current facilities map and the current site survey area are shown relative to the image of the hangar. An enlarged version of the hangar image is shown in Figure 22, superimposed on the site survey grid and site features (Figure 8).

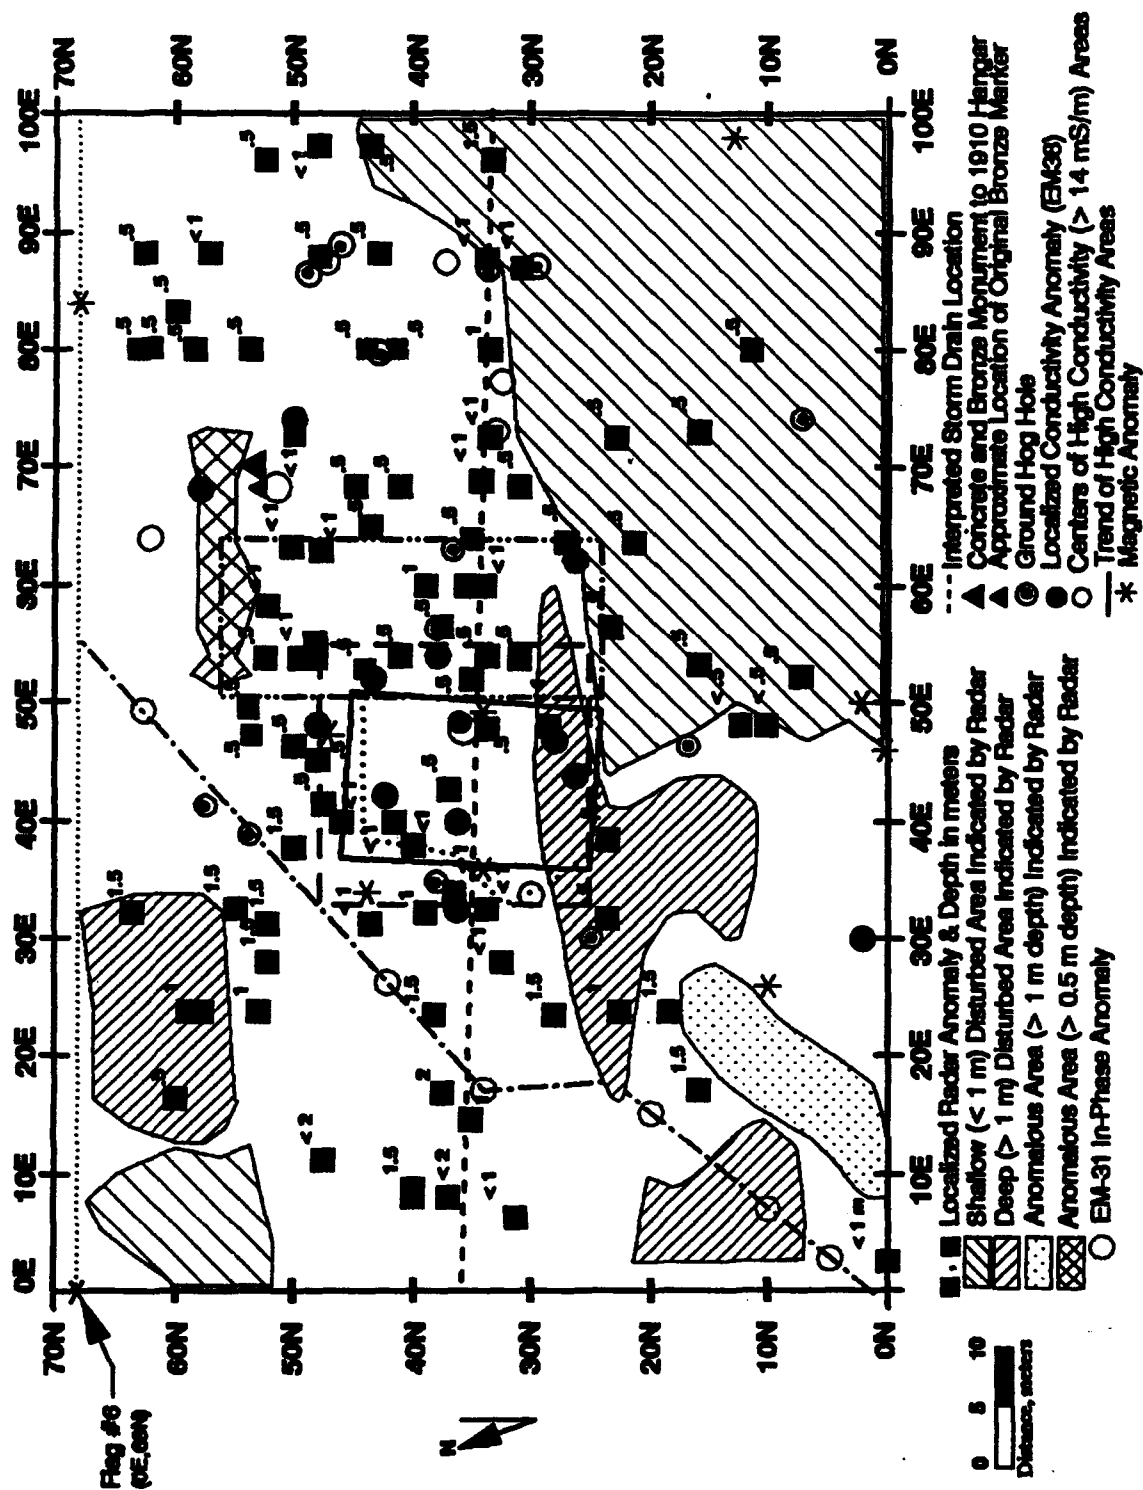
Figure 23. Integrated location map of geophysical anomalies and site features

Figure 23 represents an attempt to display the key results in a concise form. Included in Figure 23 are GPR anomalies, magnetic anomalies, in-phase EM anomalies, EM conductivity anomalies, ground hog holes, location of the existing 1910 hangar monument, the anomalous GPR rectangular area (from Figure 19), a possible extension of the rectangular anomalous area, the rectangular area with a high concentration of EM anomalies (from Figure 15), and an outline of the hangar as revealed in the 1924 aerial photograph. The rectangular/quasi-rectangular areas are shown in Figure 24 without the clutter of the other anomalies. The possible extension of the rectangular GPR anomalous area was deduced from a detailed examination of the GPR records subsequent to georeferencing the 1924 aerial photograph of the hangar to the site survey grid, and may not have been noted otherwise.

Several of the localized GPR anomalies are possibly caused by ground hog holes; these GPR anomalies are indicated in Figure 23 by yellow squares.

The "dashed" rectangular area in Figures 23 and 24 was originally defined based on enclosing 9 localized electromagnetic anomalies. It is highly significant that the dashed area also encloses 5 magnetic anomalies, numerous localized GPR anomalies, and completely encloses the hangar location indicated by the aerial photograph ("solid" rectangular area). The "dot-dash" rectangular area in Figures 23 and 24, originally defined based on a distinctive GPR anomaly signature, encloses numerous localized GPR anomalies and 3 localized EM anomalies. The dot-dash area is immediately adjacent to the hangar location indicated by the aerial photograph.

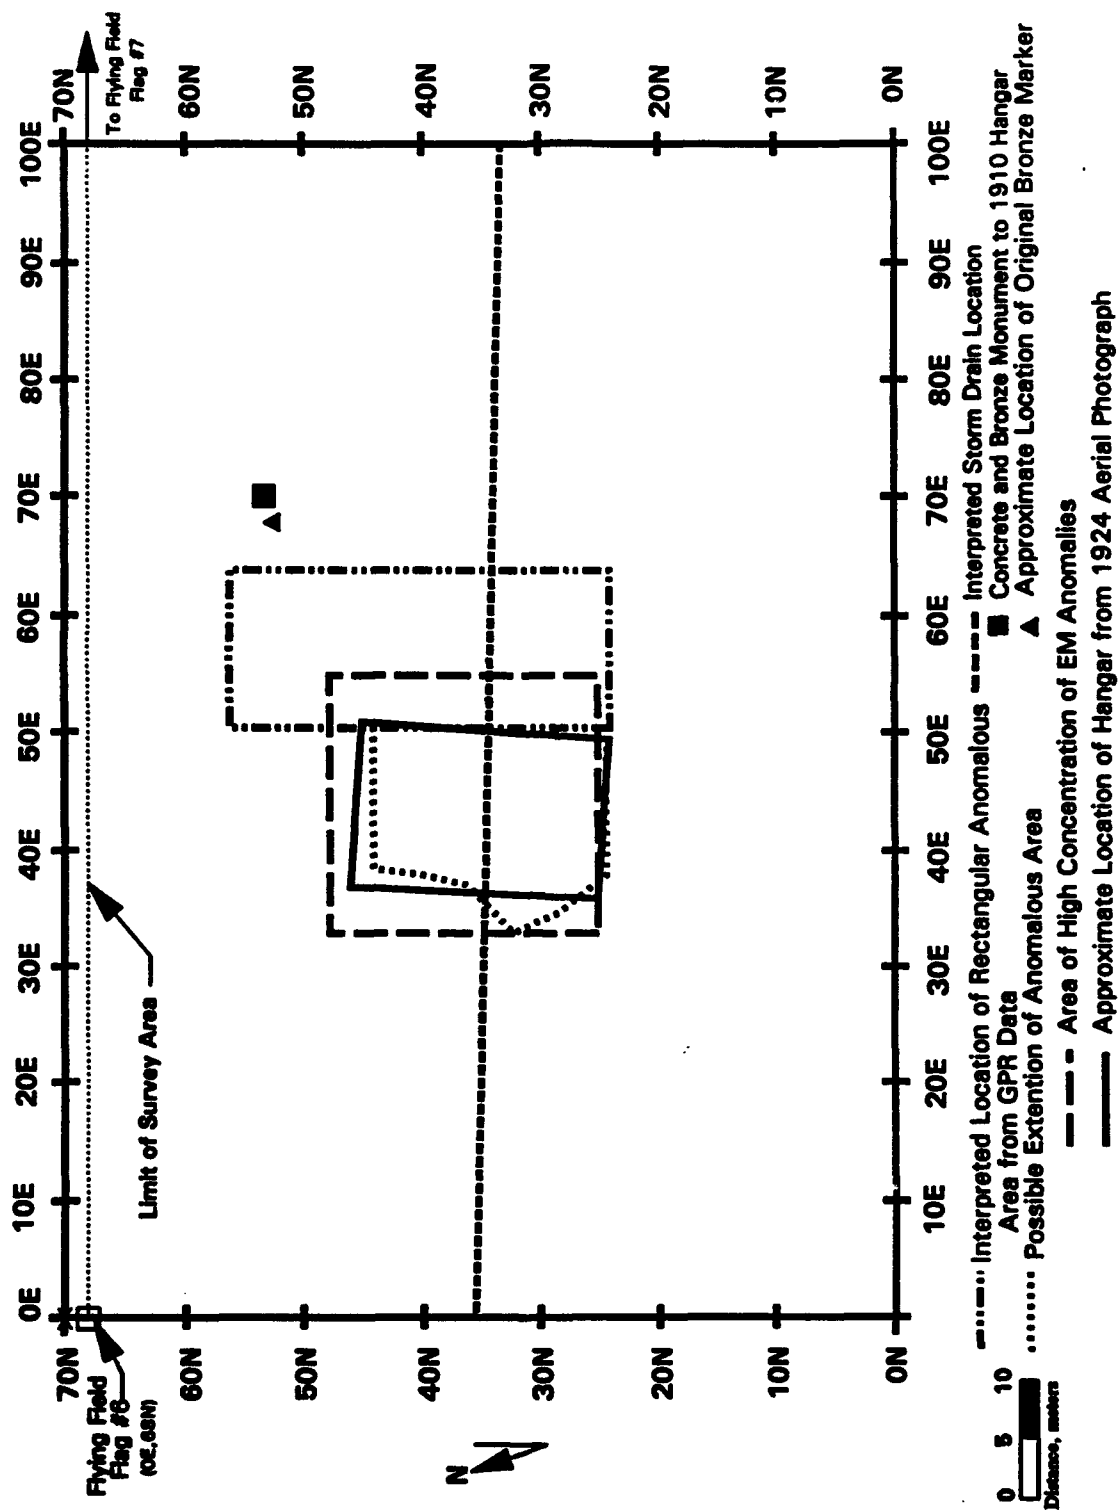
Figure 24. Comparison of interpreted rectangular anomalous areas with hangar location deduced from 1924 aerial photograph

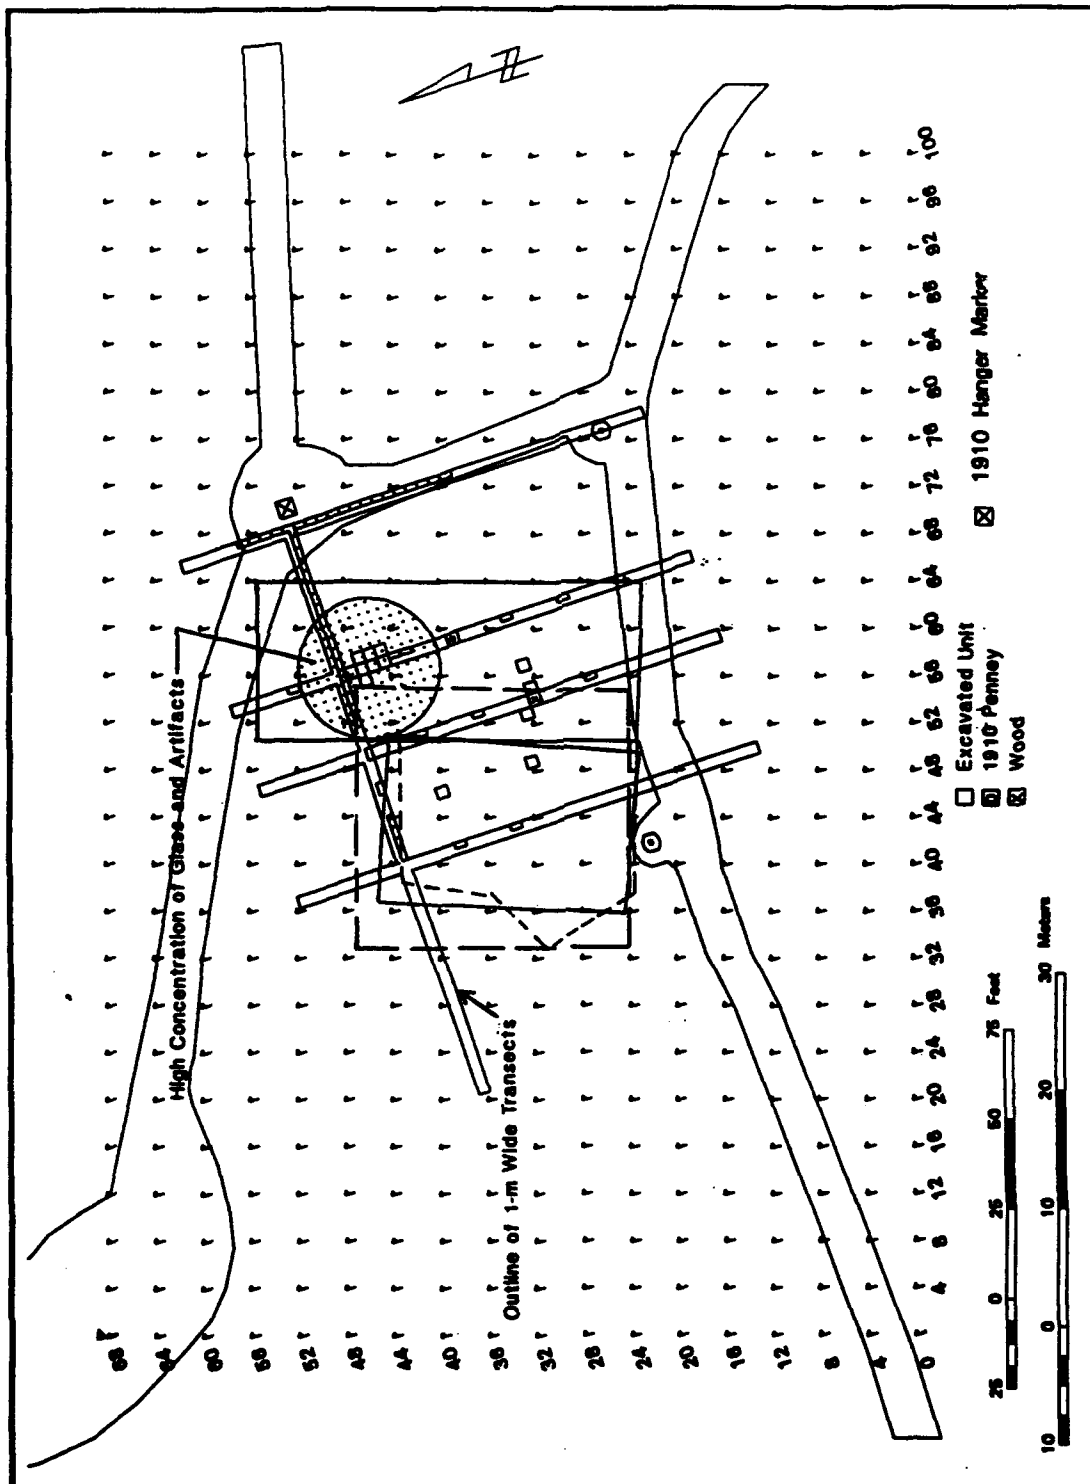
Figure 25. Superposition of archaeological excavation plan, site survey grid, geophysical anomalous areas, and hanger location from 1924 aerial photograph

Figure 25 is a site survey grid and current feature map with the 1990 CERL archaeological excavation plan superimposed. The shaded, circular area indicates the location of a high concentration of glass debris and other artifacts found by the CERL team. Also, the locations of buried wood and a 1910 penny found in excavated blocks are indicated. Most of the artifacts found by the CERL team are within the rectangular, significant GPR anomalous area.

Based on the integrated methods results, follow-up archaeological investigations (excavations) should be concentrated in the rectangular areas indicated in Figures 23-25. The highest priority excavation sites should be centered on locations where magnetic anomalies are located and where multiple geophysical anomalies are indicated. Magnetic anomaly locations are given in Table 1. Excavation at a magnetic anomaly location should extend *at least* to the depth indicated in Table 1 and outward from the location *at least* to a 1-m radius. The shaded boxes in Figure 26 indicate multiple geophysical anomaly areas. Some of the multiple geophysical anomaly areas in Figure 26 include some of the magnetic anomalies from Table 1. The significance of the remaining GPR and EM anomalies cannot be assessed; it is recommended that, at a minimum, remaining anomaly locations within and immediately adjacent to the rectangular areas in Figure 23 be investigated. Additional localized anomalies and anomalous areas should clearly have lower priority than the locations and areas discussed above.

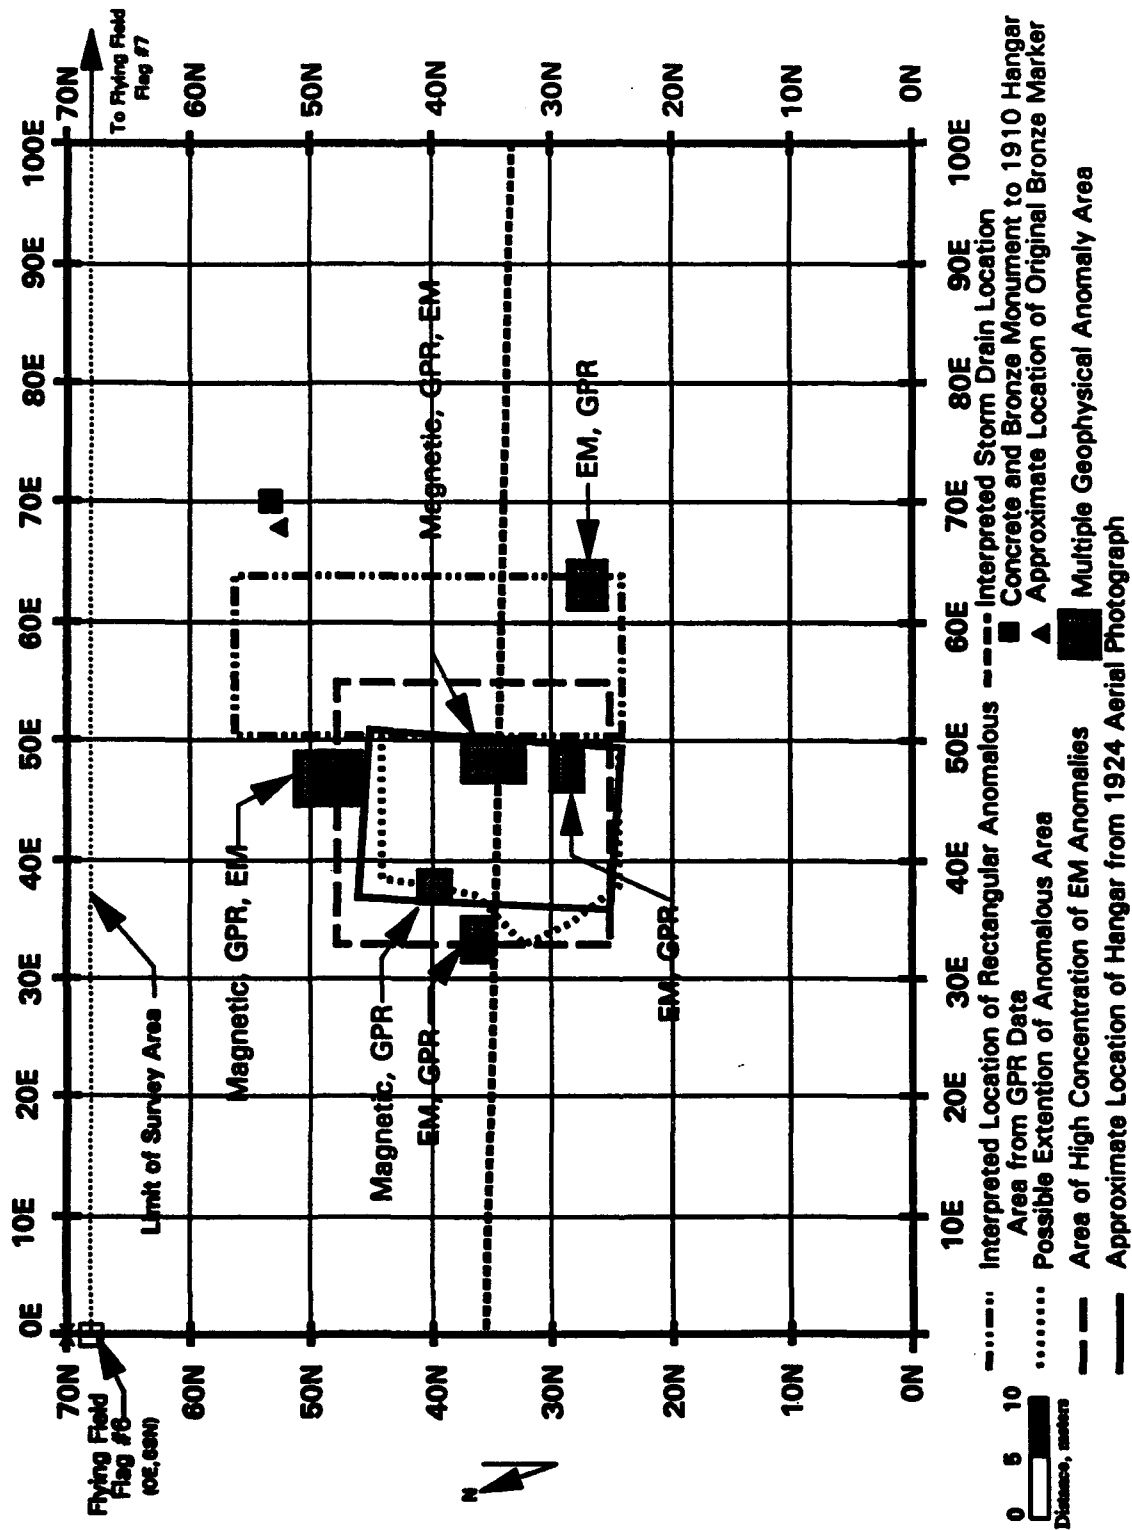
Figure 26. Locations of multiple geophysical anomaly areas
